Evaluating Minnesota Homes
Final Report

Prepared for:
The Minnesota Department of Commerce

By:
Sheltersource, Inc.

June 30, 2002

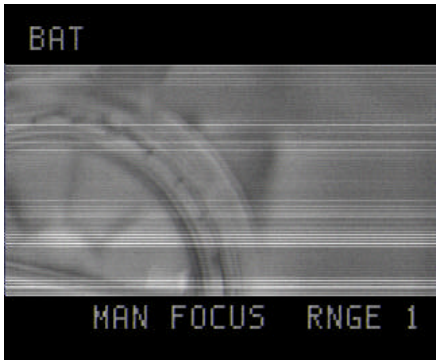
The above images illustrate an obvious void and serve as a good example of what can be found with infrared imaging. The dark areas in the infrared image correspond to the cold surfaces caused by the missing insulation. This was in a 1998 home where a ventilation system was retrofit. The insulation was not put back in place properly after the exterior hood and flex duct for the ventilation system were installed.

This infrared image shows an insulation void in the corner of the arched window in this 1998 home. This is a typical scenario for this detail due to the amount of framing members necessary to support this window and the small amount of space left to provide insulation, but this image would indicate that there is no insulation placed in that cavity.

Careful installation of the insulation material, adequate air barriers, and wind-wash protection where applicable help to eliminate insulation voids and ensure the effectiveness of insulation. Insulation voids do occur in Minnesota homes and attention to detail during the framing and insulation process is necessary to avoid them.

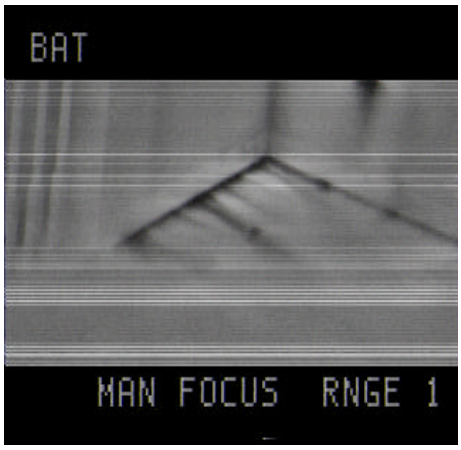
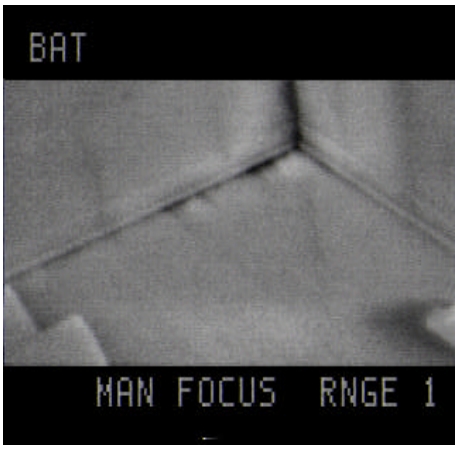
Bottom Plate Leakage

These pictures show air leakage from the crack between a sub-floor and bottom plate. Typically the leakage is greater in exterior corners of the floor due to the complex connection of the adjoining walls and the physical properties of wood to expand and contract with slight changes in moisture and temperatures. Using a plate gasket in between the sub-floor and the bottom plate or caulking the bottom plate to the sub-floor are two common ways of preventing this air leakage pathway.

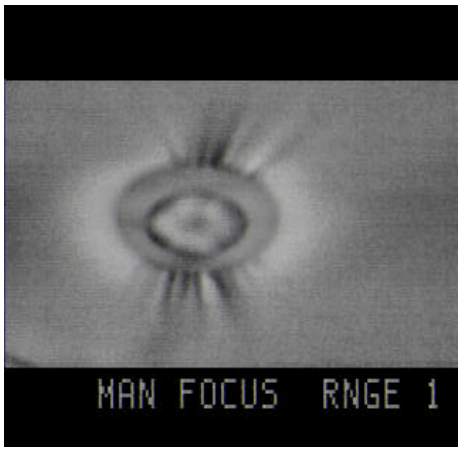
Air-leakage through recessed lights has a direct connection to the attic space. This picture shows cold air being drawn in from an unconditioned attic above the recessed light fixture. Most Category 1 and 7672 homes demonstrated better air sealing at this location. Increased availability of sealed recessed lights and careful installation are essential to the success of reducing air leakage at this detail.

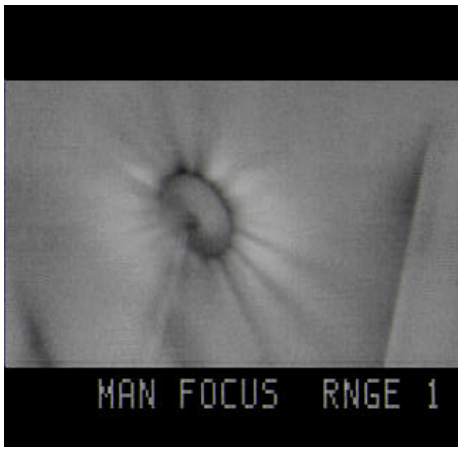
Light fixtures and other fixtures such as speakers were also noted to have considerable leakage characteristics. This leakage was noted in 1994, 1998 and year 2000 construction.

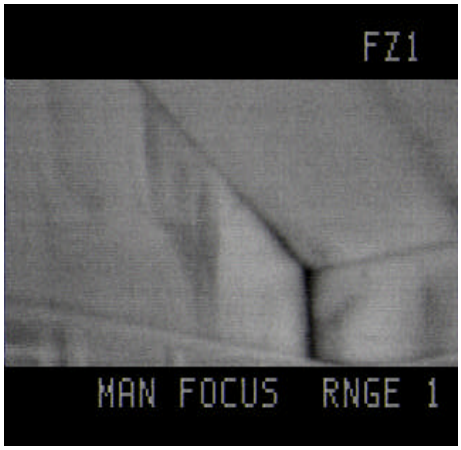
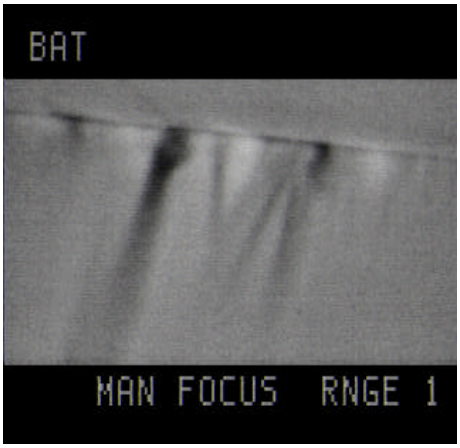
The pictures above show cold air (the dark plumes) from the attic leaking into interior wall cavities from the top plates. The cold air could be coming through unsealed wiring penetrations or through unsealed cracks between the sheetrock and top plates. Observe not only the darkened corners and edges of the top plate, but also the dark spots forming between the stud cavities. This migration of cold air is caused by an air path present in the wall cavity that is connected to the inside of the home. There was evidence of top plate leakage from all of the code types, but seemed to be less prevalent in year 2000 homes. The potential for this leakage is variable depending on the outside perimeter and the complexity of design. Homes with larger perimeters and complex features have more potential for leakage than more compact homes.

Sealing all the holes in the top plate with caulk or expanding foam and completely sealing the union of the sheetrock and the top plate will reduce the amount of air leakage between the attic and interior wall cavities. When the top plate is properly sealed the air path will be eliminated and thus reduce the overall air leakage rate.

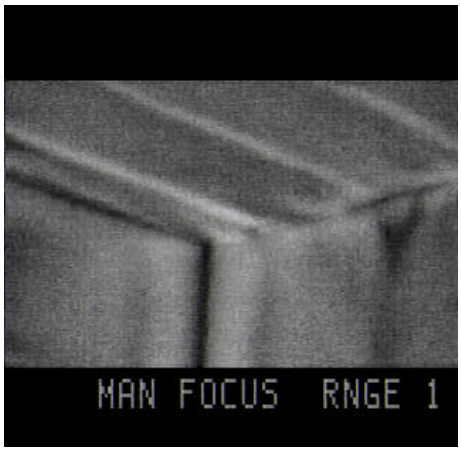
These are shots of air leakage from floor cavities situated over attached garages. Both of the pictures are observed from adjacent kitchens. Note that the floor trusses are white because they retain heat longer than the un-insulated cavities around them that are getting washed with cold air. This was noticed in homes of all code types.

The leakage shown here was observed from an unsealed rim joist in a Category 2 home. There are also air leaks noticeable above the patio door.

This staining is a common visual indication of rim leakage in a main floor rim of a 1994 home. The batt of insulation has been filtering infiltration for some time. Again, the proper sealing of the rim joist would prevent the air leakage from spilling into the basement.

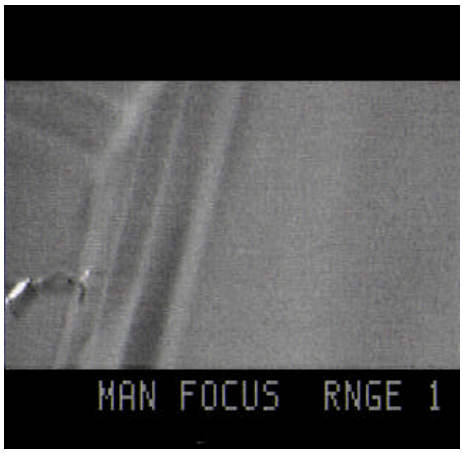
Plumbing cavities

This is a second floor shower stall that is adjacent to an exterior wall and below an unconditioned attic. The object on the left of the picture is a showerhead. The white lines are warm studs, which are highlighted in black because of cold air filling the cavity.

As easily as the air can enter the wall cavity under test conditions, warm moist air can travel in the opposite direction during the winter. When this happens, accumulation of water in the wall cavity may occur due to condensation, challenging the systems durability.

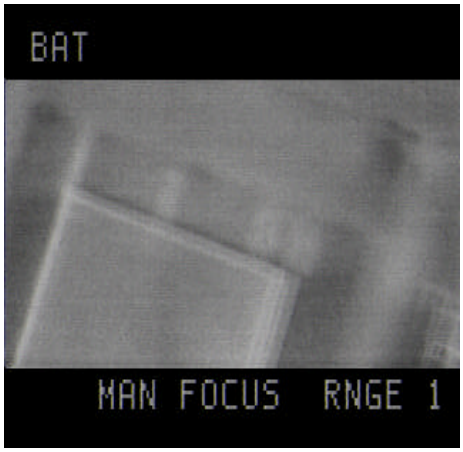
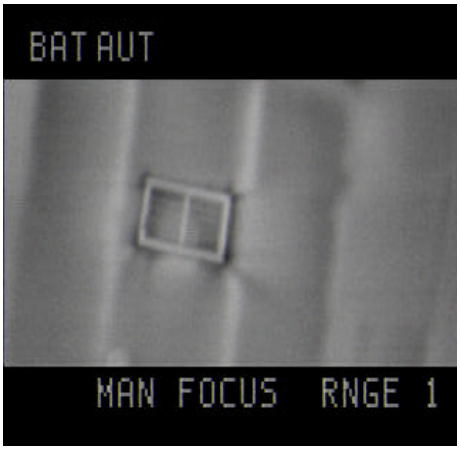
Both of these pictures are framed fireplace cavities on exterior walls. Just as with the plumbing wall, the interior studs of these cavities appear warm when compared to the adjacent sheetrock. Had the cavity been sealed from exterior leakage, there would not be as significant a temperature difference and the dark areas would not be as evident.

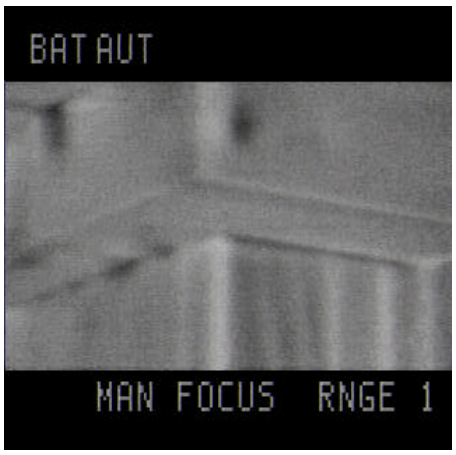
This is a dropped soffit in the basement of a 1998 home with an air leakage signature similar to those of the framing cavities above.

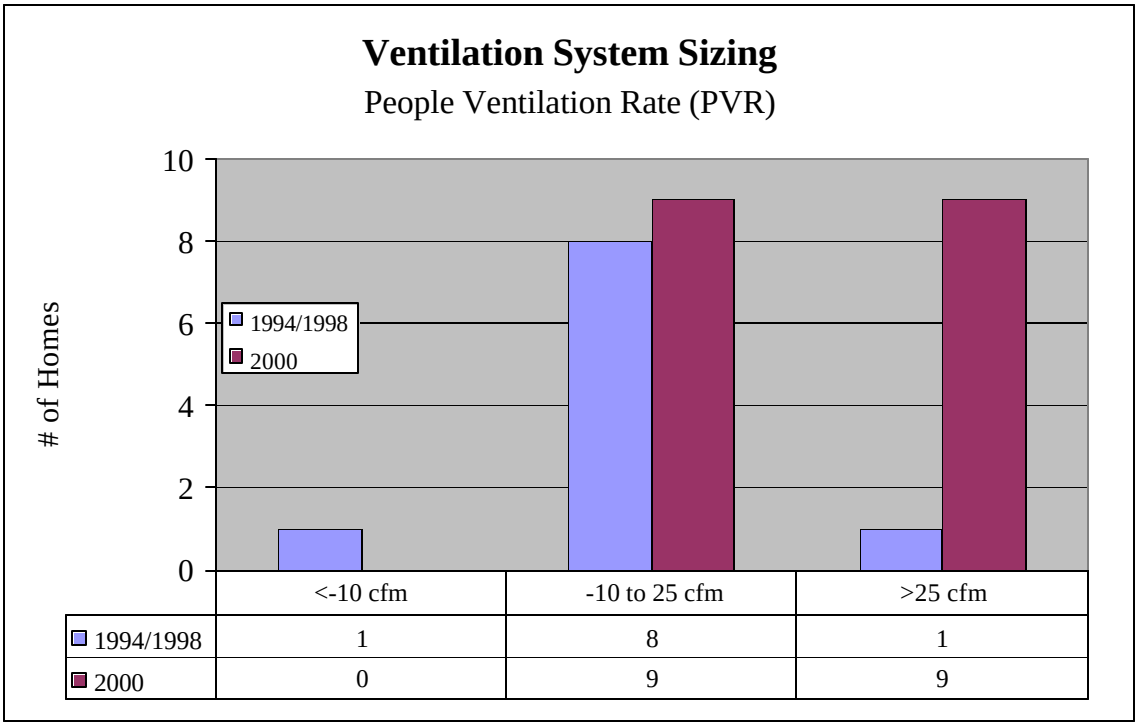
Two of the 10 (20%) 1994/1998 homes and 2 of 18 (11%) year 2000 homes with mechanical ventilation systems did not meet the recommended PVR. The 4 homes missed the PVR by 13 cfm, 9 cfm, 6 cfm and 3 cfm. 7 of the 10 (70%) 1994/1998 homes and 7 of the 18 (39%) year 2000 homes either met or exceeded the recommended PVR by less than 25 cfm. One of the 10 (10%) in the 1994/1998 dataset and 9 of the 18 (50%) whole house ventilation systems installed in the year 2000 exceeded the PVR by more than 25 cfm. This does not necessarily present a problem other than a slight increase in energy use. The systems that missed the design target ventilation rates still provide ventilation. Increased activity, larger families and other various site conditions can all contribute to variations in pollutant levels, but the PVR does not reflect this need for varying ventilation rates since it is based on the number of bedrooms. Even systems designed to the proper ventilation rate could be inadequate if adverse conditions existed.

The largest difference between the rated PVR and actual PVR was a 1998 house that exceeded the recommended ventilation rate by 68 cfm. This HRV system was operating at 128 cfm on low speed although the minimum requirement for this 3-bedroom home is 60 cfm. Much lower continuous ventilation rates have been known to result in excessively low levels of relative humidity (RH) in Minnesota homes during the winter, but in this case the homeowners were satisfied with their indoor relative humidity. In fact, this was one of the 3 homes in the study where a ventilation system was installed to help solve a window condensation problem. The homeowners were satisfied with the ventilation system's performance and indicated that it had reduced window condensation. They did not indicate that low RH was a problem. RH monitoring equipment that was left at this home during the final week of February 2001 and the first three weeks of March indicated that this home maintained an average relative humidity of 26% during that period.

One homeowner in this study did not operate the HRV in his home because he felt it did "over-dry" the structure. The HRV was operating at 105 cfm on low speed, exceeding the recommended 75 cfm PVR by 30 cfm.

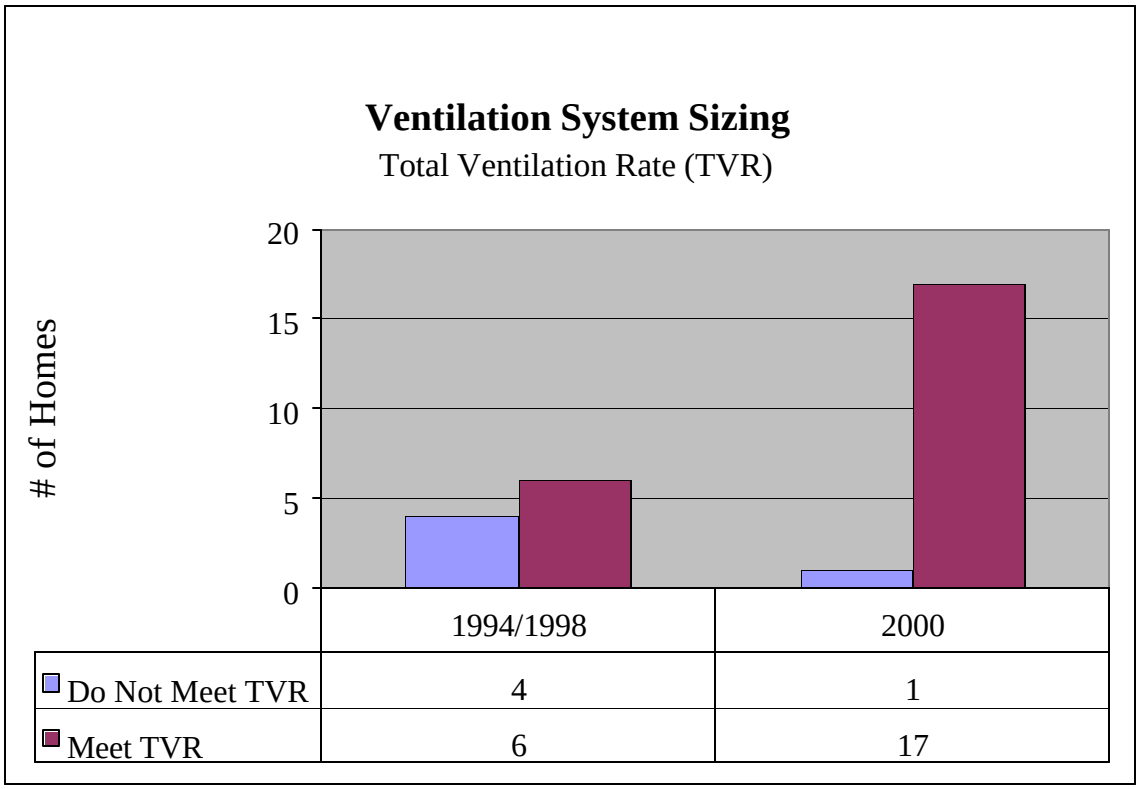
The four 1994/1998 ventilation systems missed the TVR by 52 cfm, 28, cfm, 28 cfm and 21 cfm. The year 2000 home missed the recommended TVR by 118 cfm. The average 1994/1998 home exceeded the recommended TVR by 63 cfm; the average year 2000 system exceeded the recommended TVR by 70 cfm.

All of the ventilation systems that did not meet the recommended TVR were source point balanced ventilation systems. Three of these systems did not have supplemental exhaust fans; one of the 1994/1998 homes had one supplemental exhaust fan. Of the 3 source point systems that did meet the TVR, one had one additional exhaust fan in the master

bathroom and 2 of the homes had 3 additional bathroom exhaust fans. Only one of the source point ventilation systems in this study would have met the recommended TVR without added exhaust fan capacity.

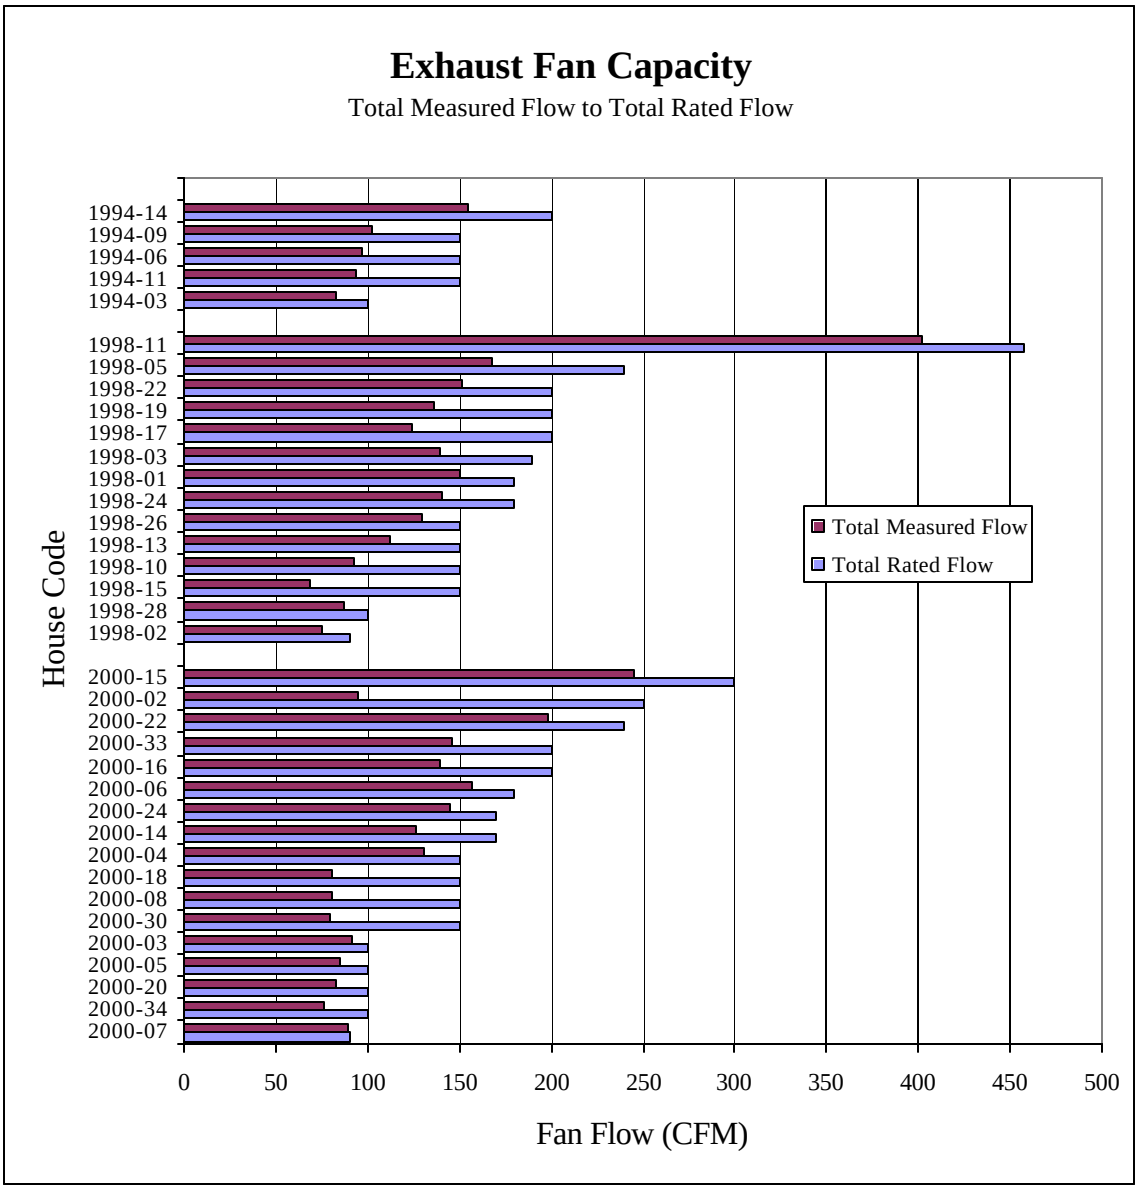
Long equivalent duct lengths also affect the performance of bathroom exhaust fans. The chart above shows the total rated exhaust fan capacity compared to the total measured exhaust fan capacity for each home with exhaust fans installed. A home with four bathroom exhaust fans, each rated for 50 cfm, would have a 200 cfm total rated exhaust capacity. For example, house 1998-11 had 457 cfm of exhaust capacity. This included one 257 cfm rated in-line exhaust fan installed in a “smoking room” which was intended to provide intermittent exhaust, along with 4 bathroom exhaust fans rated at 50 cfm. The actual measured flow rate was 402 cfm.

The average measured exhaust capacity was 71% of the total rated capacity in the 1994 homes, 74% in the 1998 homes and 75% in the year 2000 data set.

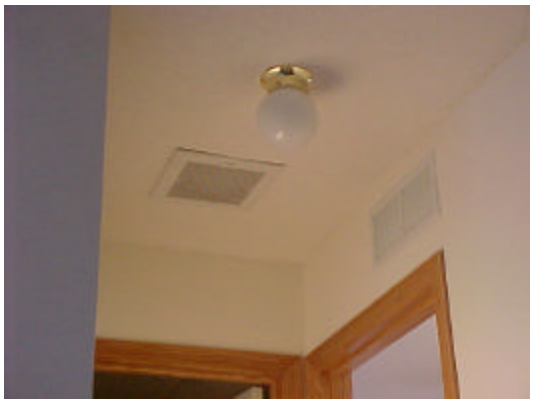
The three exhaust-only systems had the people ventilation fan installed centrally in a 2nd floor hallway. Each of the homes had open staircases that allowed for air movement from the main floor.

Each of the systems had a labeled people fan switch similar to this installed in the basement.

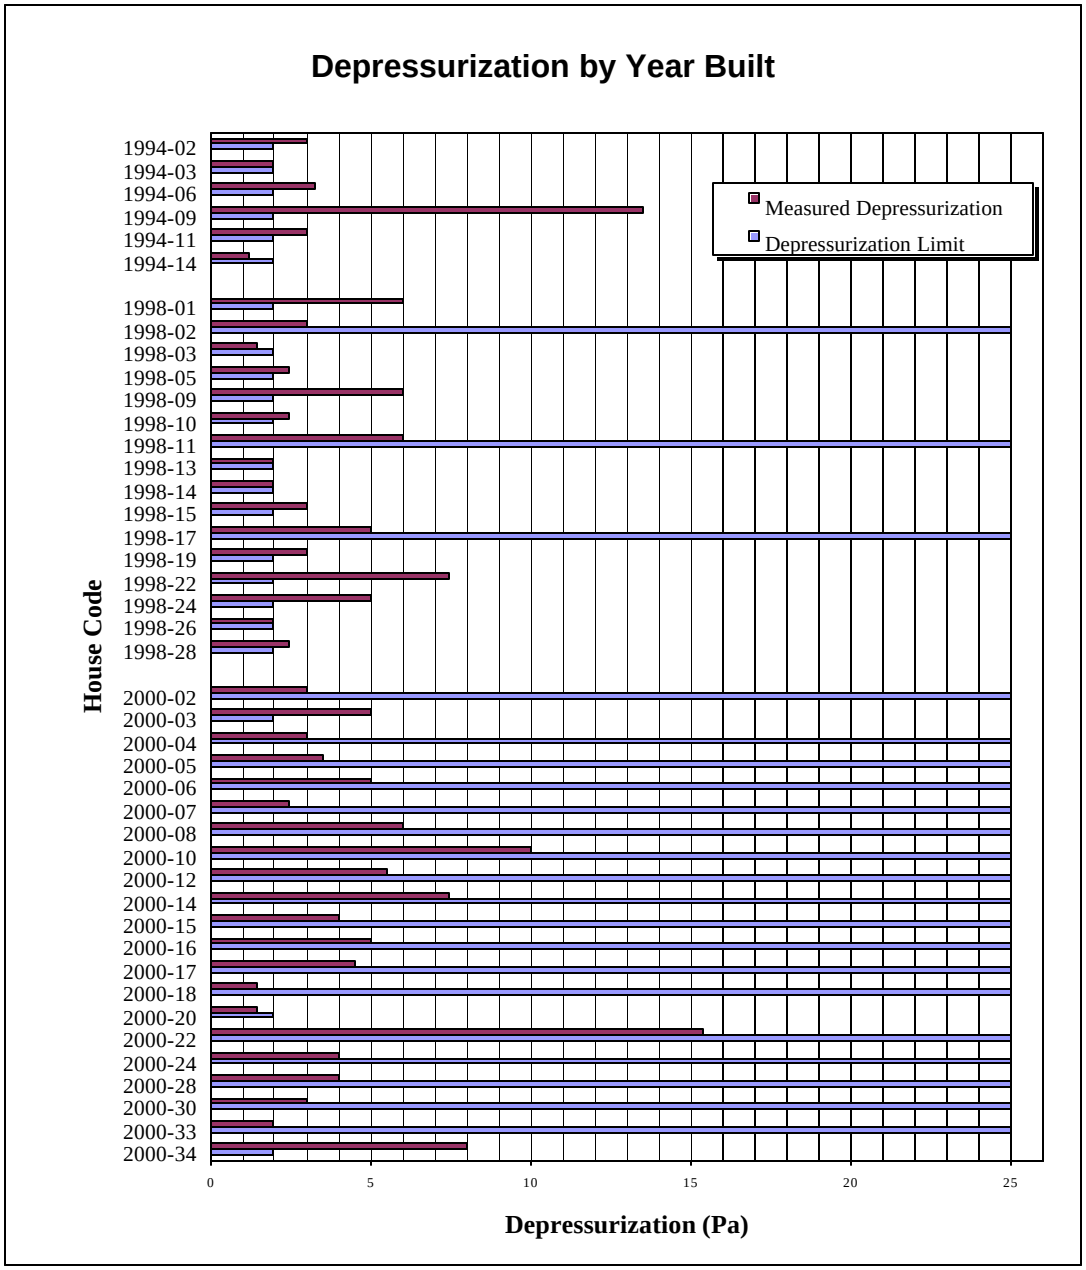
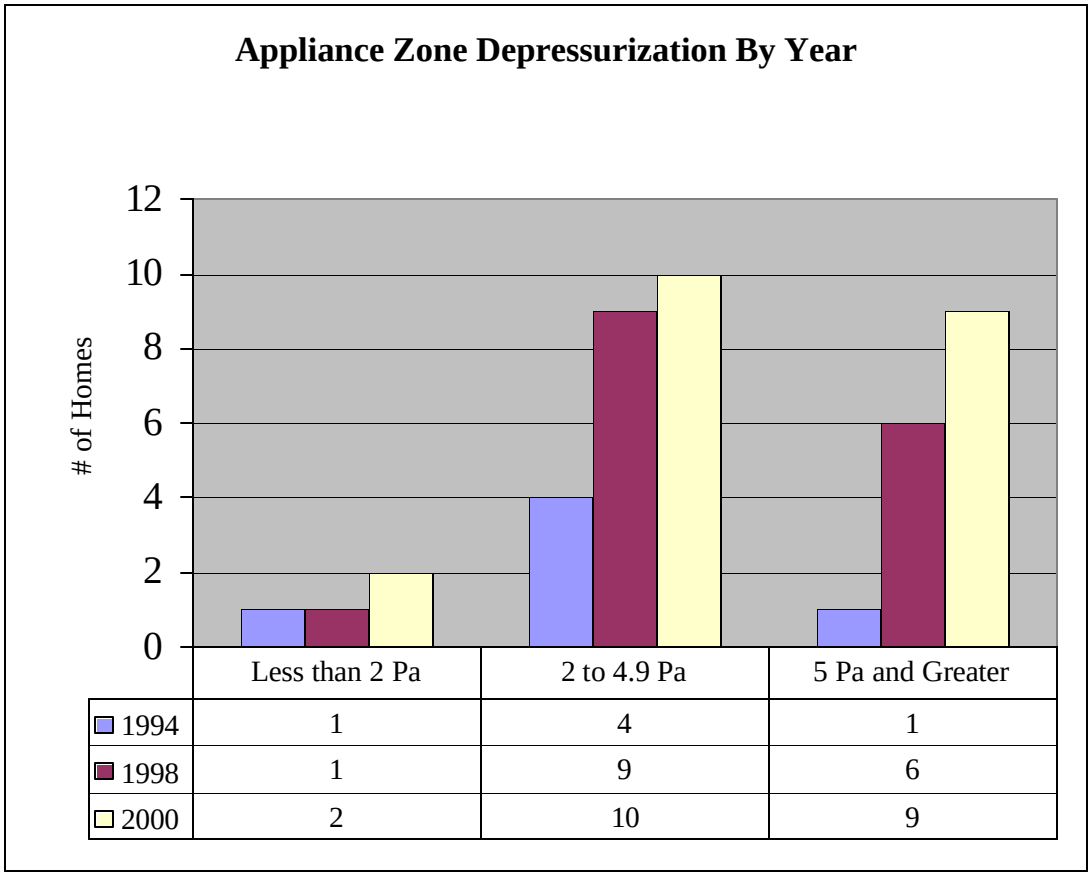
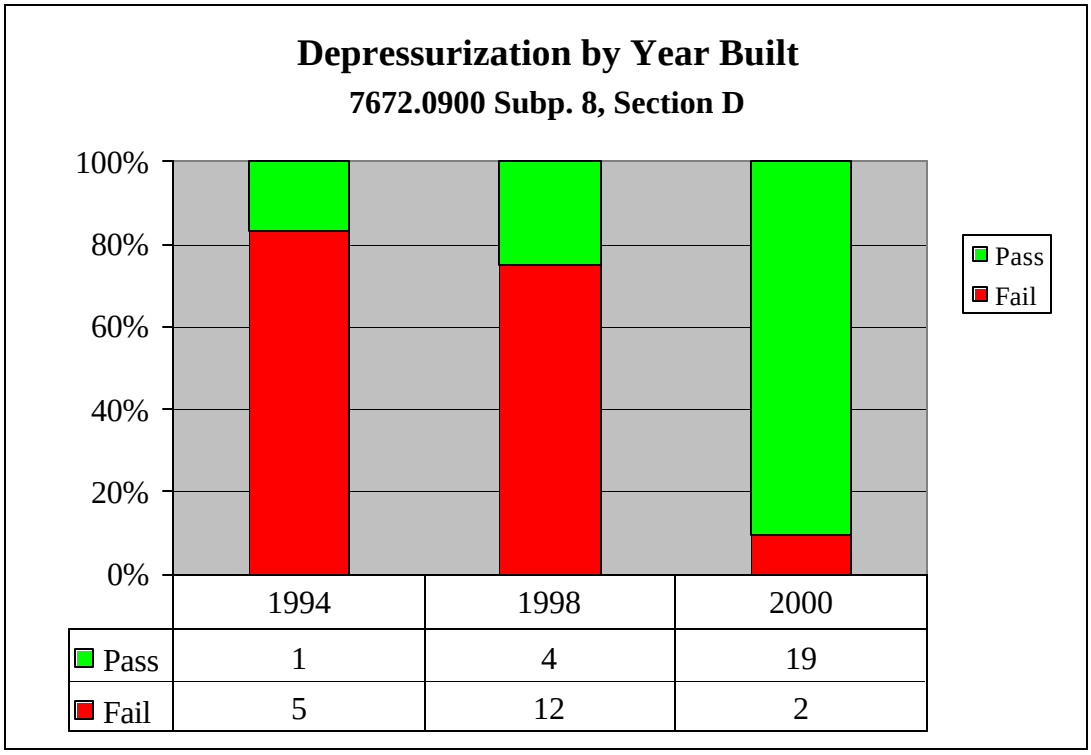
Depressurization in this 43-house dataset ranged from 1.2 to 15.4 pascals. The average house was depressurized by 4.3 pascals. The average depressurization of the 22 homes with atmospherically vented water heaters (the appliance most susceptible to depressurization) was 3.9 pascals.

1994	1998	2000
Pass	1	4	19
Fail	5	12	2

The combustion appliance zones (CAZ) in 19 of 43 tested homes (44%) were depressurized beyond their maximum depressurization limits as set by the chapter 7672 energy code with just the dryer and next largest exhaust device operating. All of the failures were in homes with atmospherically vented water heaters. Three of the 22 homes with atmospherically vented water heaters were depressurized by less than 2 pascals.

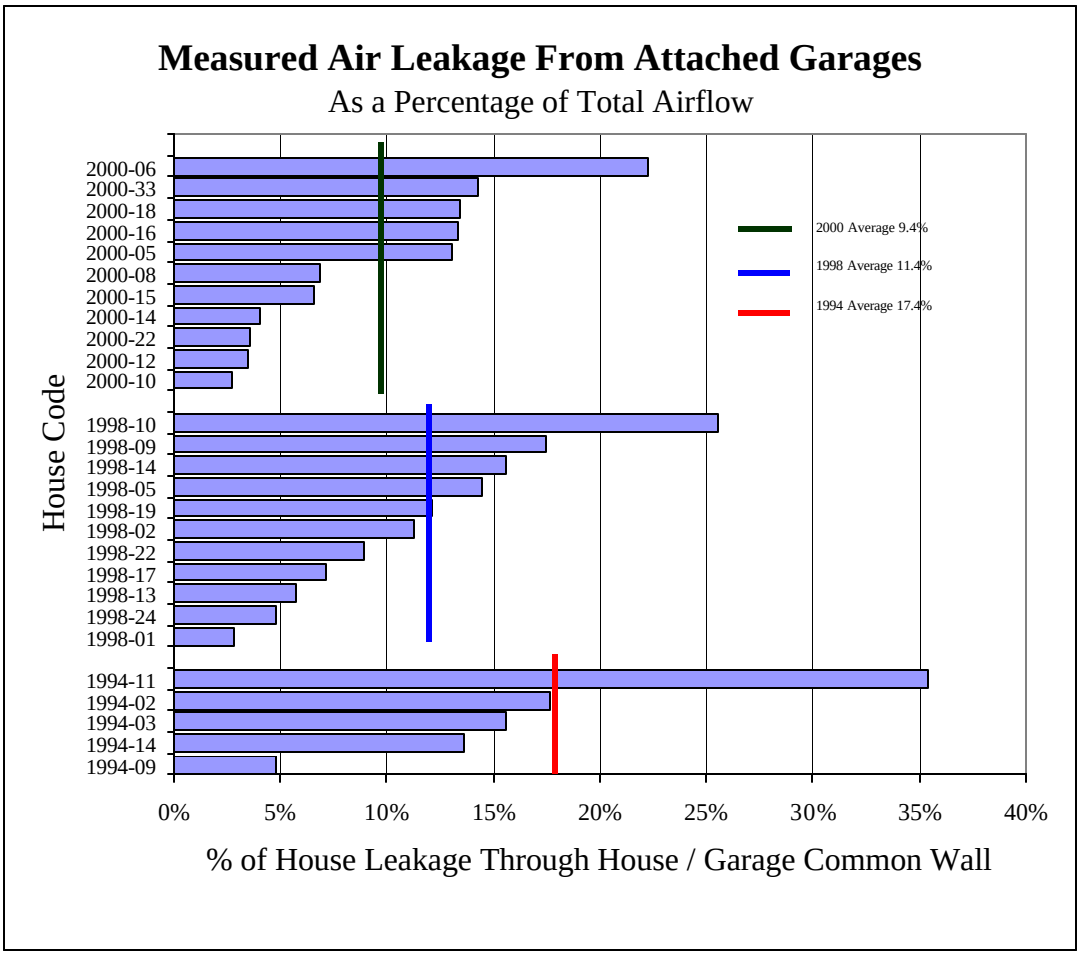
This chart displays each home's measured garage leakage as a percentage of the total house leakage of its envelope. In home 1994-02, for example, 11% of the measured leakage from this home's envelope is entering the home through the garage wall interface. Notice the downward trend in garage leakage as a percentage of total envelope leakage from 1994 to 2000.

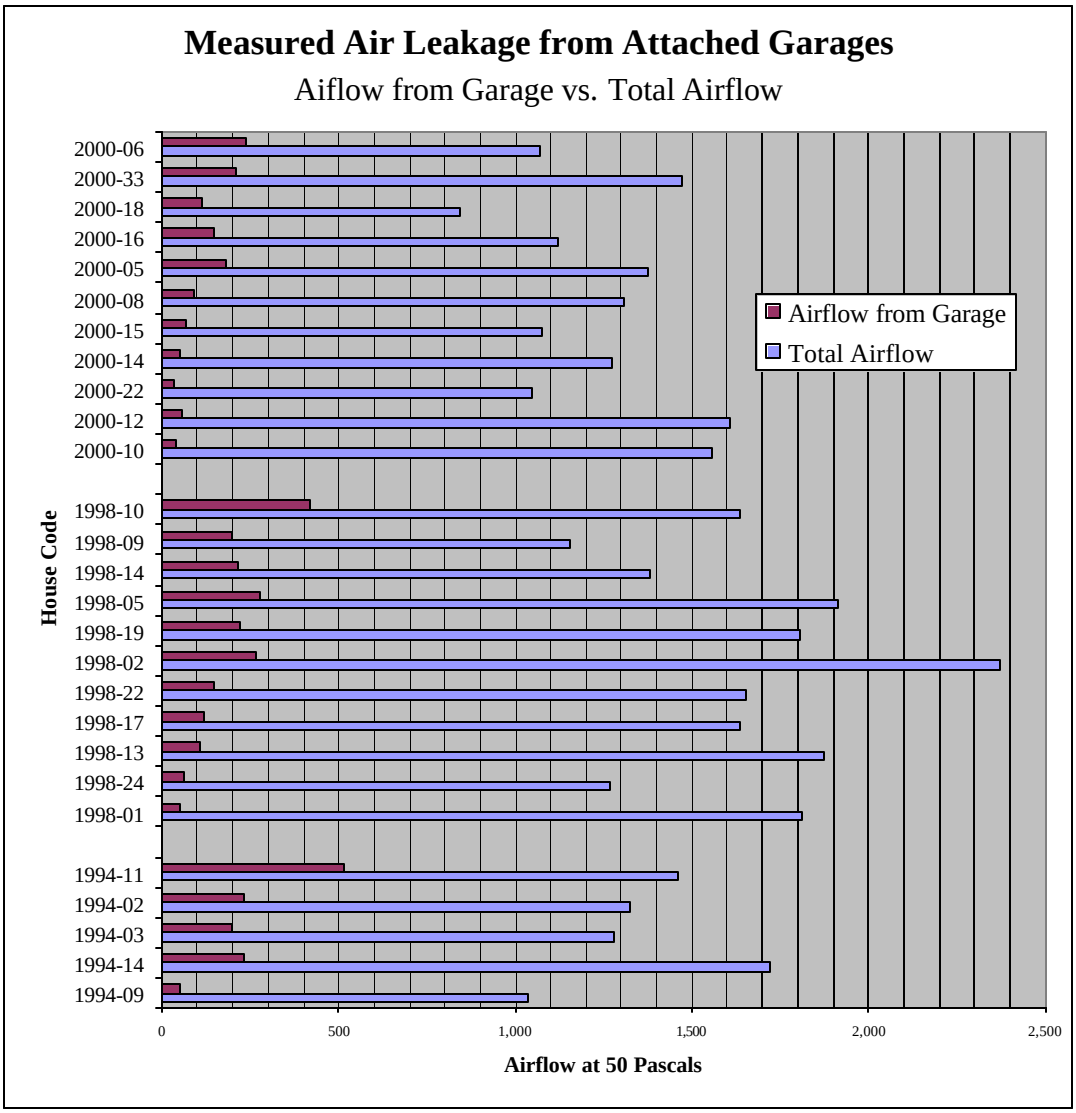
The charts above establish the average leakage rates in cubic feet per minute at the 50 pascal pressure differential used during blower door testing. Again, this indicates that air leakage from attached garages has decreased in recent years, reducing the potential for entry of hazardous air pollutants.
